INVENTORY OF MONUMENTS AT PAGAN

Volume One
Monuments 1-255

PIERRE PICHARD

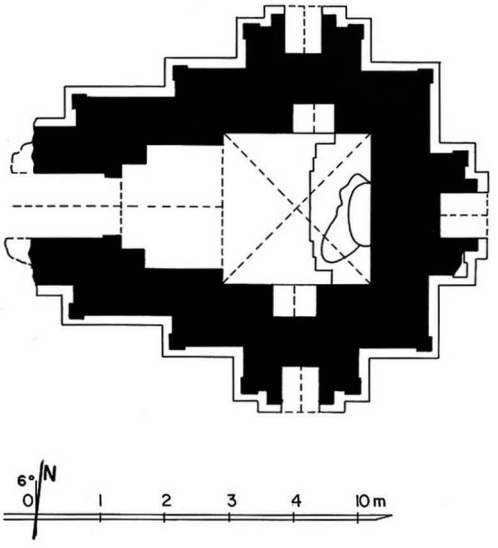
1577 a - Plan

5 present condition
- no maintenance.
- base disintegrating.
- west porch collapsed.
- upper parts badly damaged.

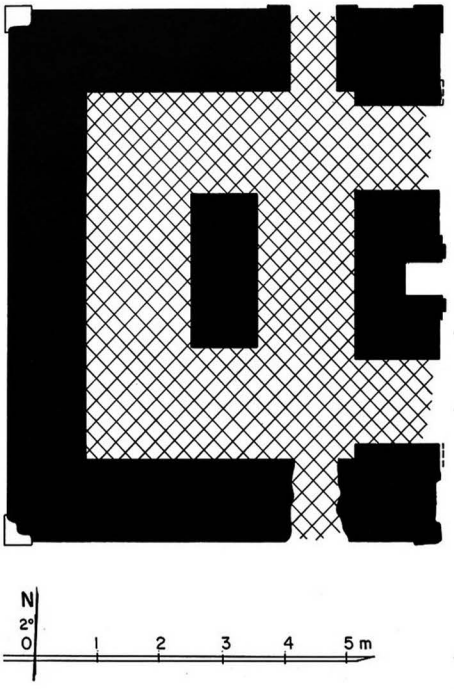
1578 a - Plan

5 present condition
- ruined.
- no more trace of vaults.
- ground floor buried under debris.

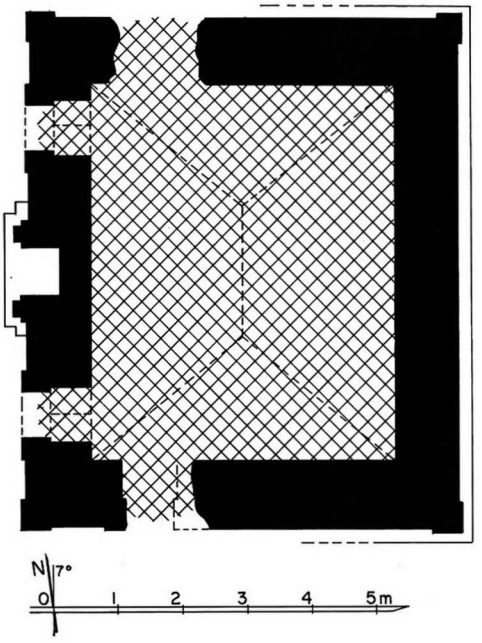
1579 a - Plan

5 present condition
- ruined.
- vault collapsed.
- ground floor buried under debris.

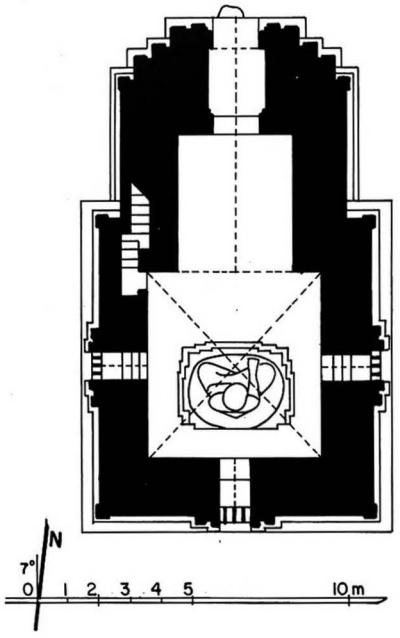
1580 a1 - Plan

5 present condition
- regularly maintained.
- repaired and strengthened (Const. Corp) 1976-82.
- paintings treated (Arch. Dept.) 1993-94.

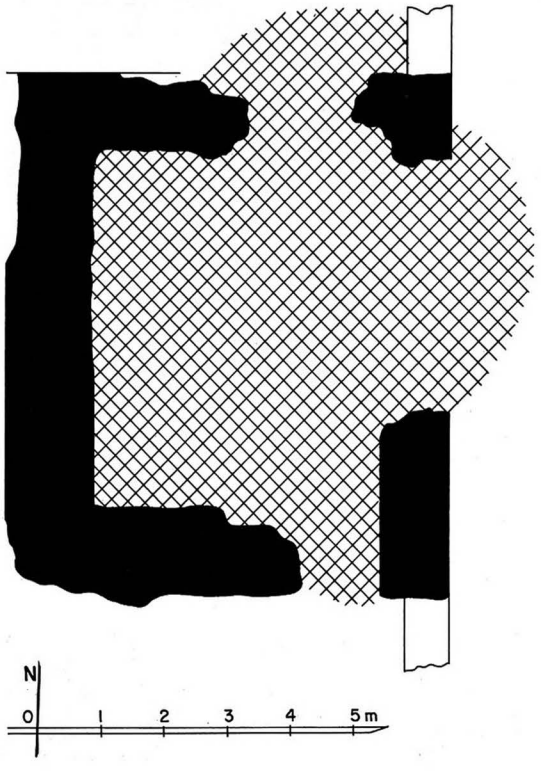
1581 a - Plan

5 present condition
- ruined.
- only base of walls remains.
- ground floor buried under debris.

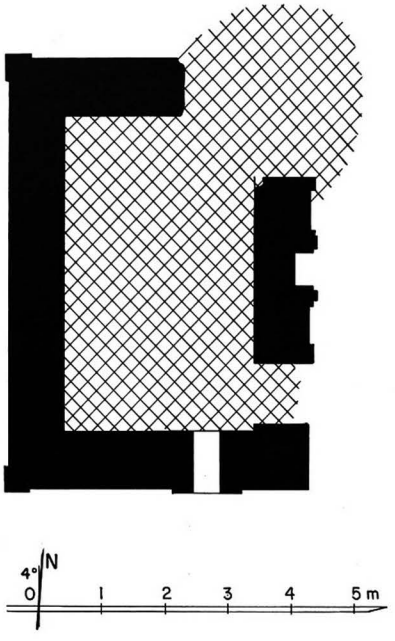
1582 a - Plan

5 present condition
- ruined.
- no more trace of vaults.
- ground floor buried under debris.

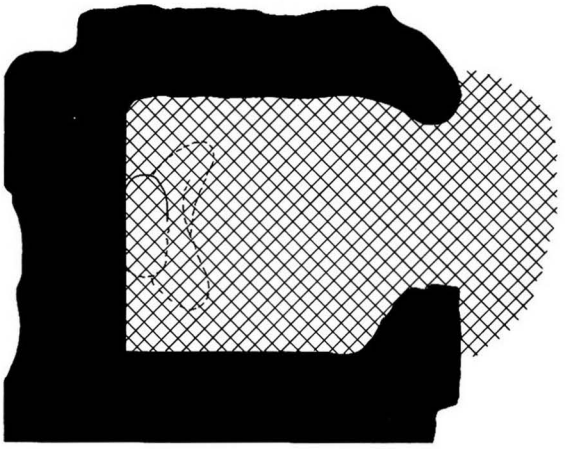
1583 a - Plan

5 present condition
- ruined.
- only base of walls remains.
- ground floor buried under debris.

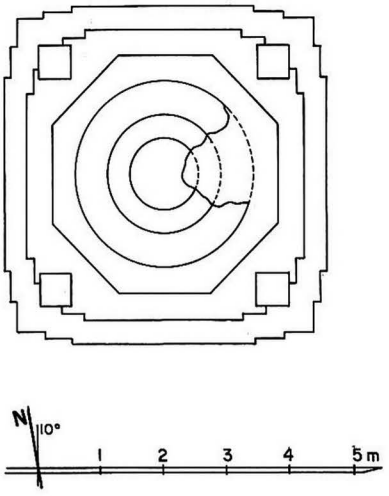
1585 a - Plan

5 present condition
- no maintenance.
- terraces disintegrated.
- upper parts badly damaged.

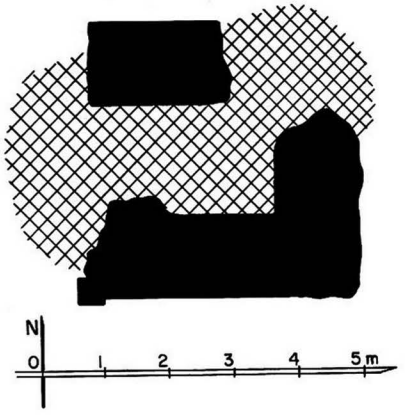
1586 a - Plan

5 present condition
- ruined.
- only base of walls remains.
- ground floor buried under debris.

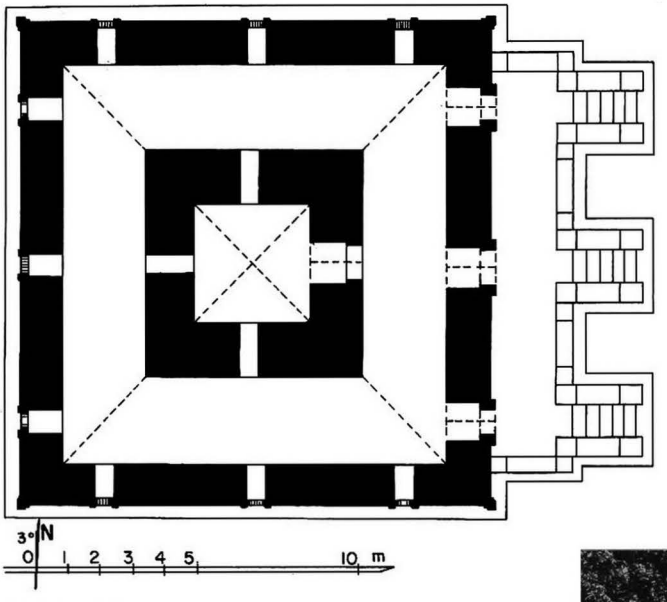
1587 a - Plan

5 present condition
- regularly maintained.
- repaired 1907.
- repaired and strengthened (Const. Corp.) 1975, 1988.
- brick grilles built by Arch. Dept.

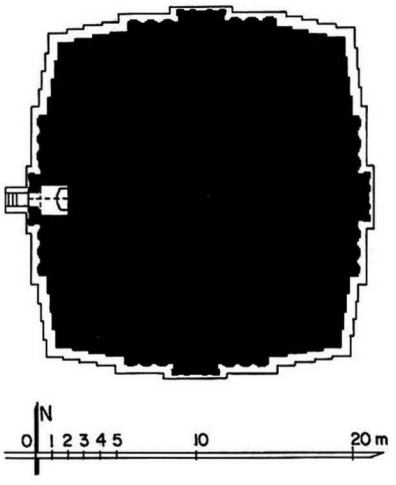
1588 a - Plan

5 present condition
- whitewashed.
- repaired 1993.

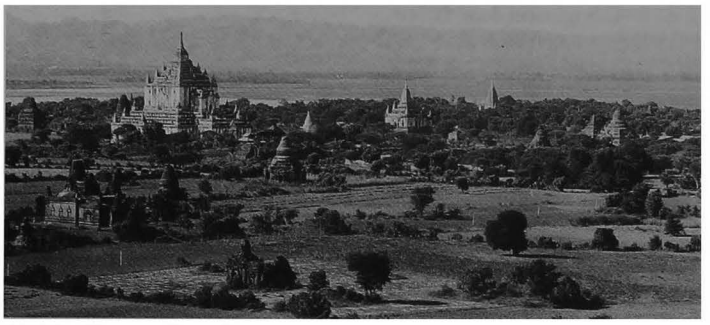
1597 b - From south-east, panoramic view taken from 771 Dhamma-yan-gyi

5 present condition
- maintained by Trustees.
- whitewashed.
- badly damaged by the 1975 earthquake.
- repaired (1975-77) and strengthened (Const. Corp.) 1991-93.

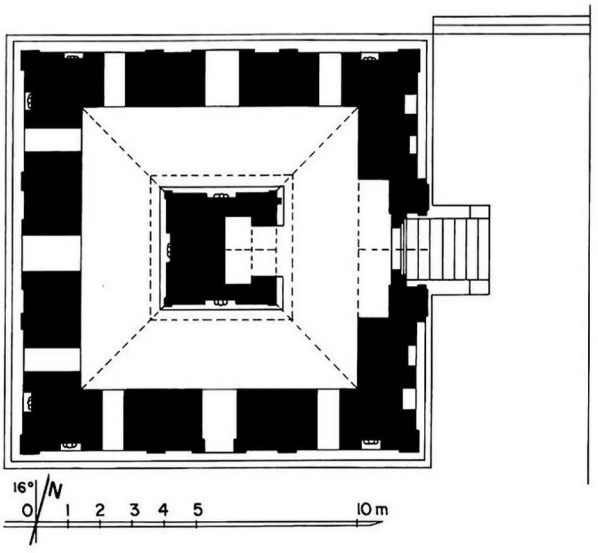
1600 a - Plan

5 present condition
- regularly maintained.
- traces of vault over outer corridor.
- repaired 1912 and 1976.

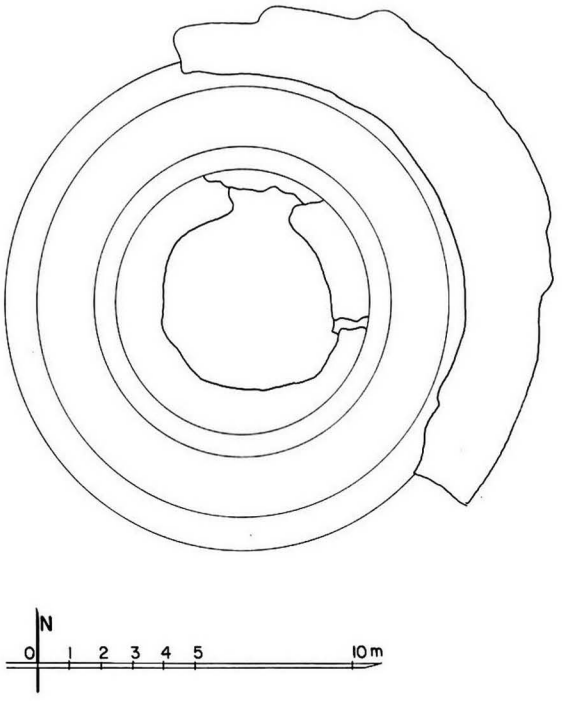
1603 a - Plan

5 present condition
- maintained.
- terraces disintegrated.
- dome badly cracked by the 1975 earthquake.
- strengthened by steel rings, (Const. Corp.) 1981.

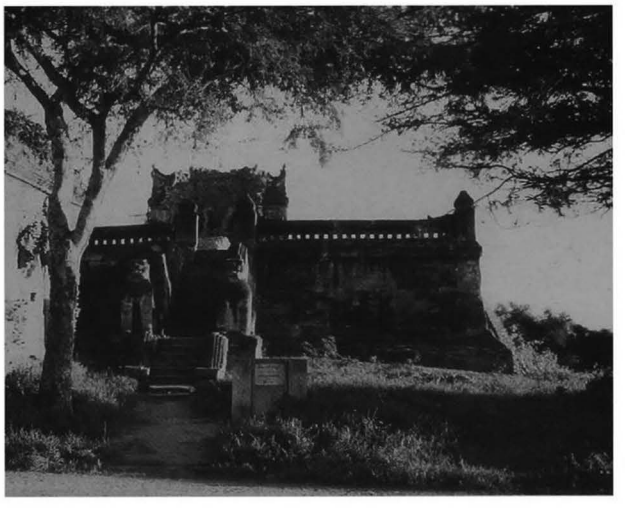
1611 e - Platform, stairway and temple, from north (1985), after repairs

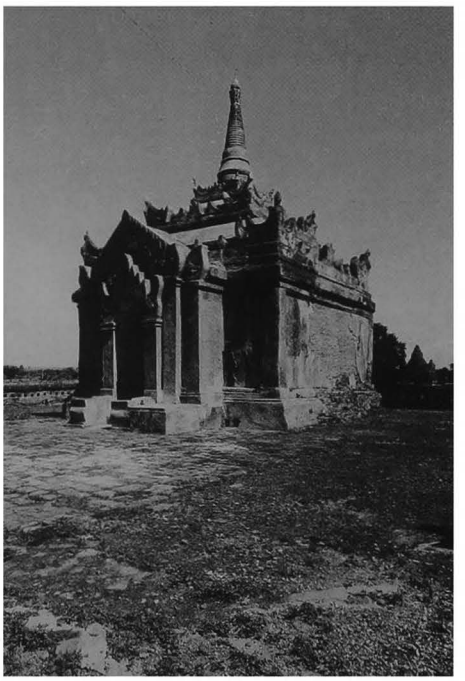
1611 g - Temple, from north-west (1987)

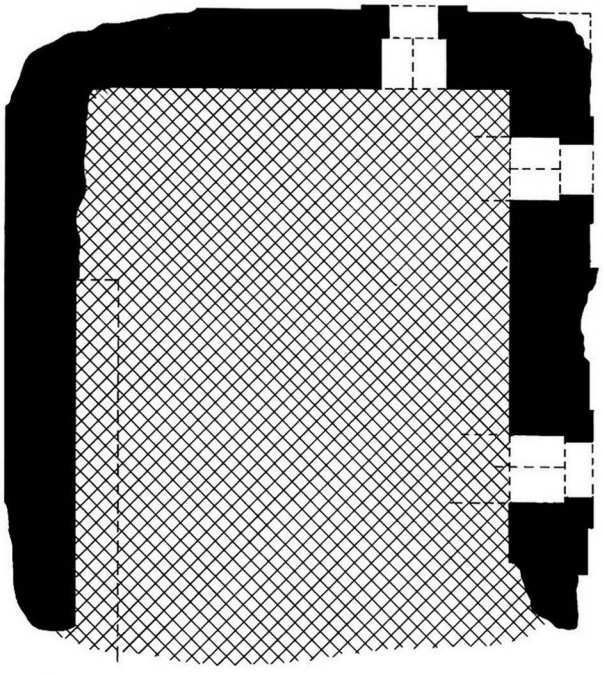
1624 a - Plan

5 present condition
- ruined.
- no more trace of vaults.
- ground floor buried under debris.

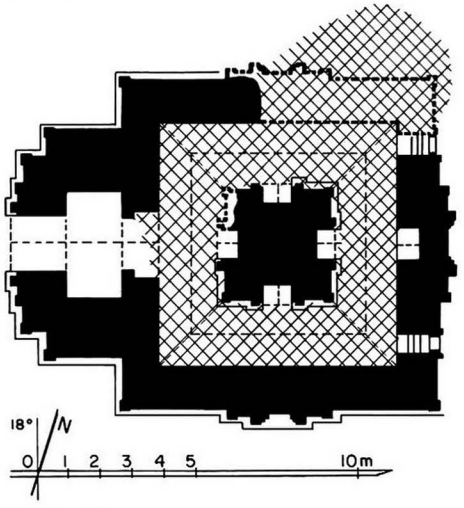
1629 a - Plan

5 present condition
- no maintenance.
- half-ruined.
- upper parts and tower destroyed by the 1975 earthquake.
- ground floor buried under debris.

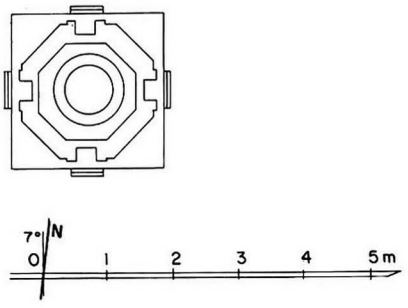
1640 a - Plan

5 present condition
- maintained by Trustees.
- leaning to south-west.

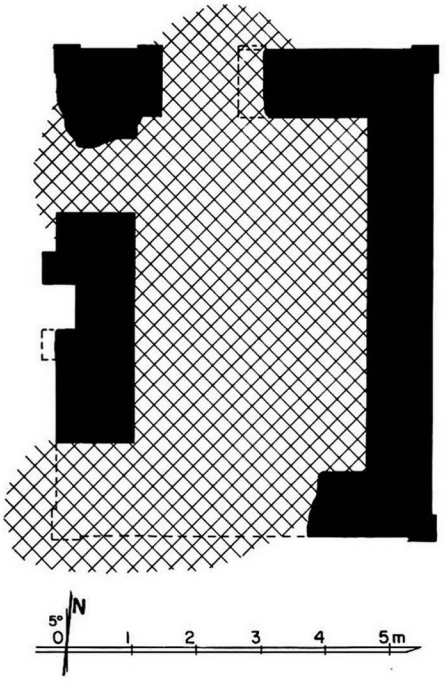
1655 a - Plan

5 present condition
- ruined.
- no more trace of vaults.
- ground floor buried under debris.

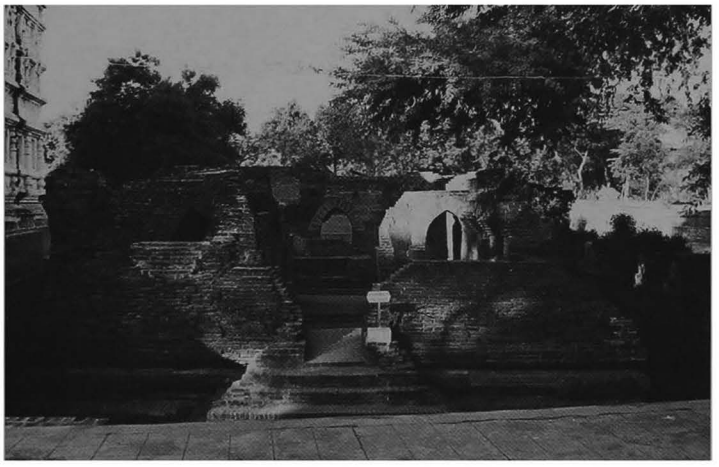
1656 e - From north-east, after repairs (1995)

5 present condition
- half-ruined.
- ground floor cleared of debris 1991.
- repaired (Const. Corp.) 1991-92.

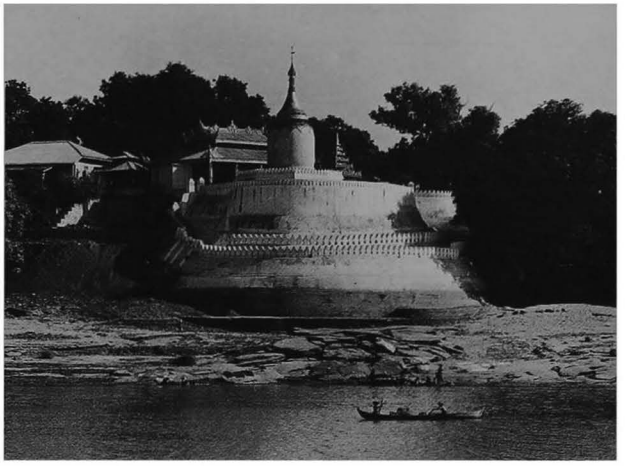
1657 c - From north-west

5 present condition
- totally destroyed by the 1975 earthquake.
- rebuilt as a hollow reinforced concrete structure (Const. Corp.) 1976-78.
- maintained by Trustees.
- whitewashed.

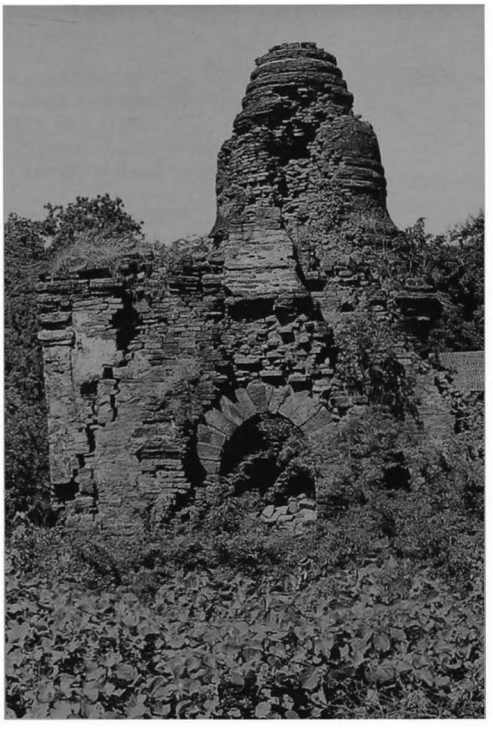
1659 d - From south-east, after repairs (1995), together with 1658

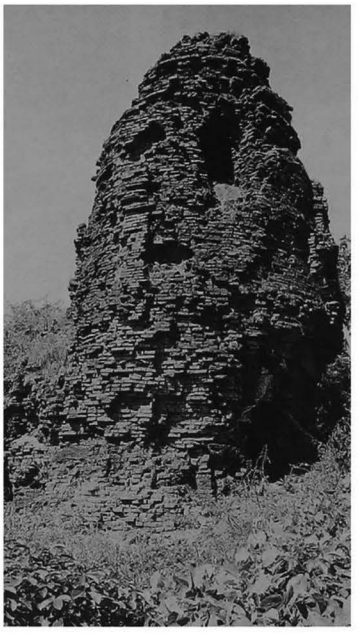
5 present condition
- half-ruined and endangered.
- terraces disintegrated.
- upper parts badly damaged.

1663 c - Fom north-east

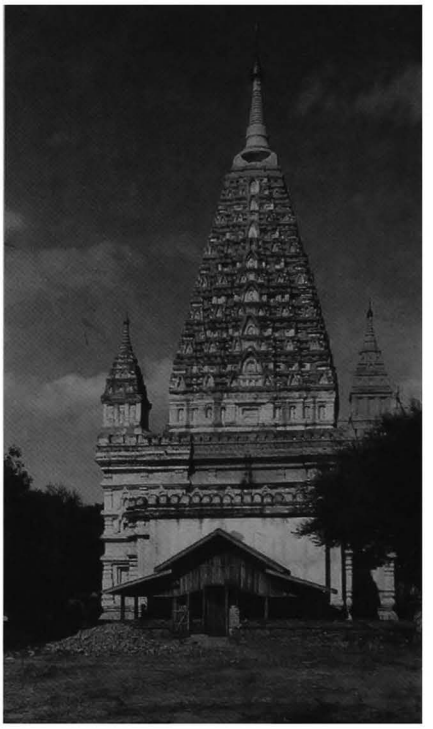
1670 d - West face

5 present condition
- maintained by Trustees.
- whitewashed.
- tower and structure badly cracked by the 1975 earthquake.
- repaired 1976-79 and strengthened (Const. Corp.) 1991-92.

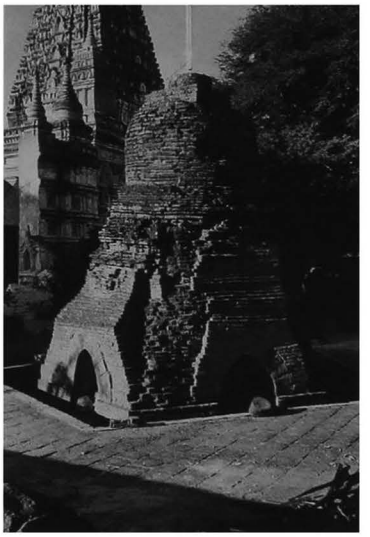
1671 e - From north-east, after repairs (1995), together with 1670 Maha-bodhi

5 present condition
- terraces disintegrated.
- upper parts damaged.
- repaired 1992.

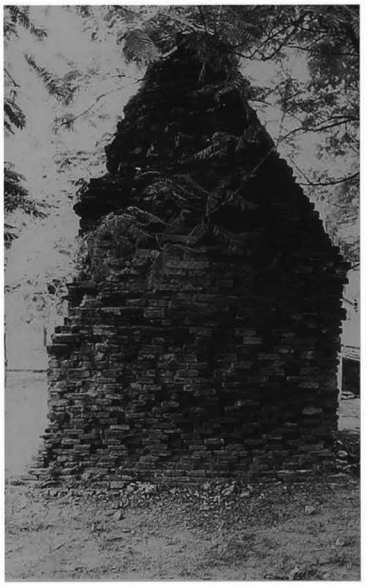
1672 b - South face (1987)

5 present condition
- repaired 1992.

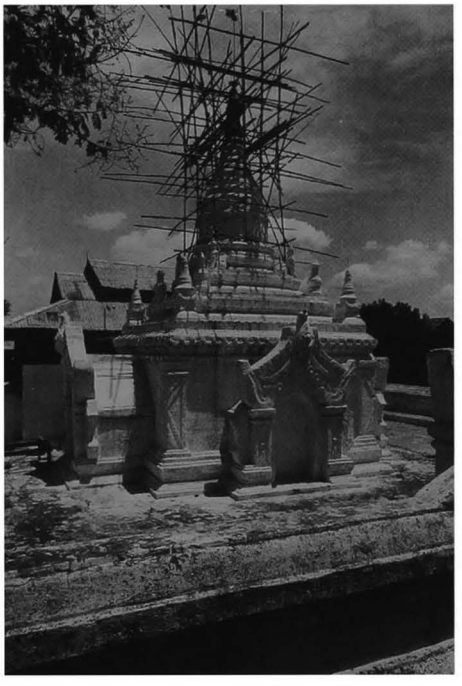
5 present condition
- maintained and whitewashed.
- spire repaired 1987.

1675 b - From north-west (1987), under repair

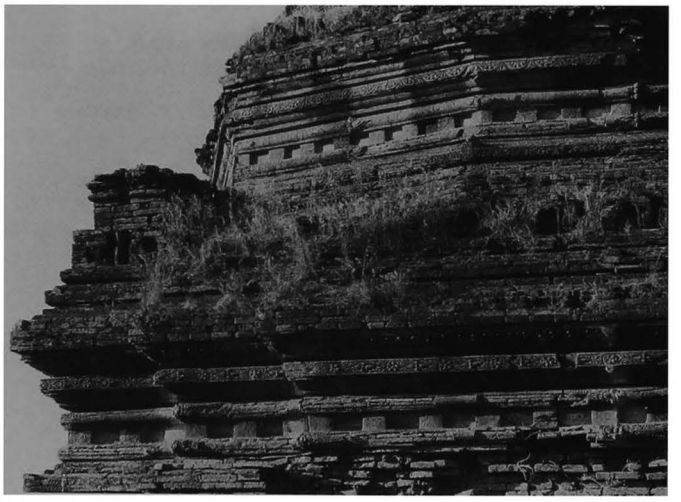
5 present condition
- no maintenance.
- base disintegrated.
- upper parts damaged.

1678 c - South face, terraces, detail of south-west corner

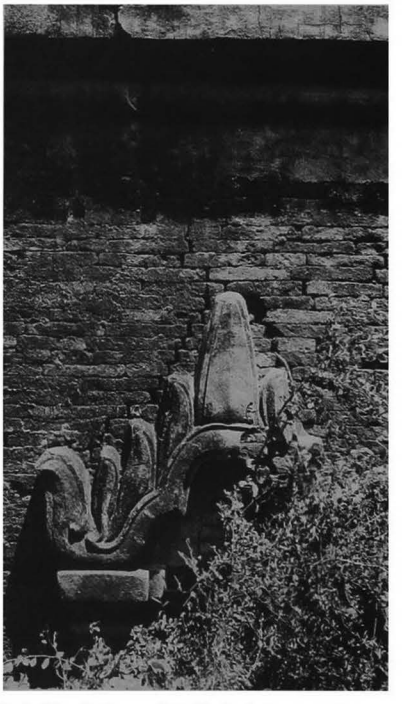
5 present condition
- ruined.
- vaults and upper parts collapsed.
- ground floor buried under debris.

1680 d - South face, detail of window pediment

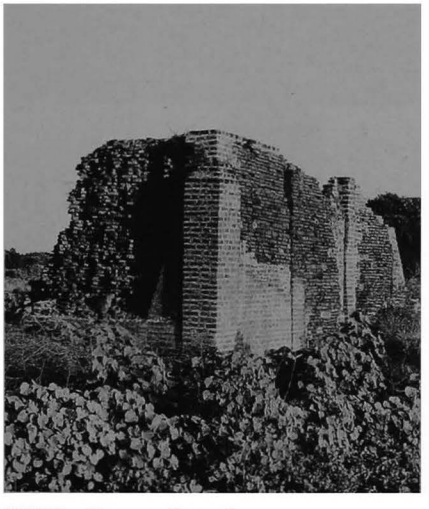
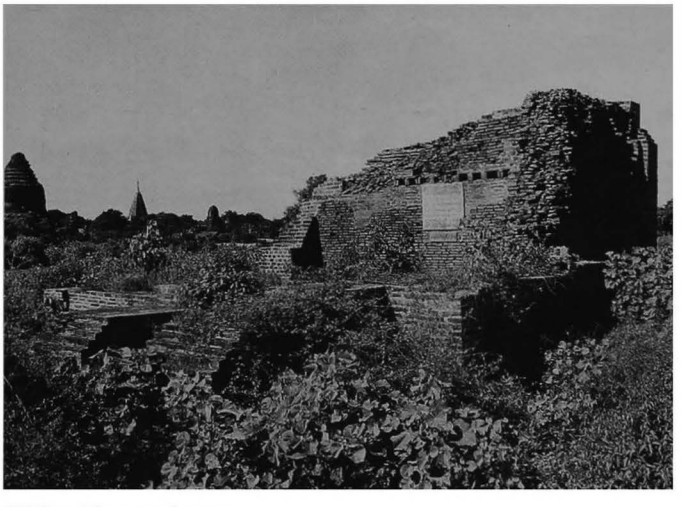
5 present condition
- ruined.
- vaults and upper parts collapsed.
- ground floor cleared of debris.
- repaired (Arch. Dept.) 1983.

1682 b - From north-west

1682 c - From north-east

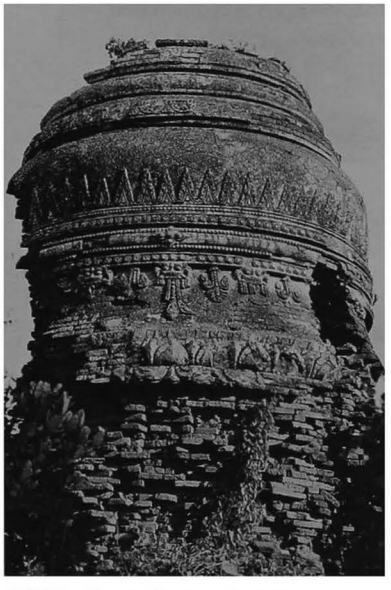
5 present condition
- no maintenance.
- half-ruined.
- terraces disintegrated.
- upper parts badly damaged.

1689 b - Dome, from north-west

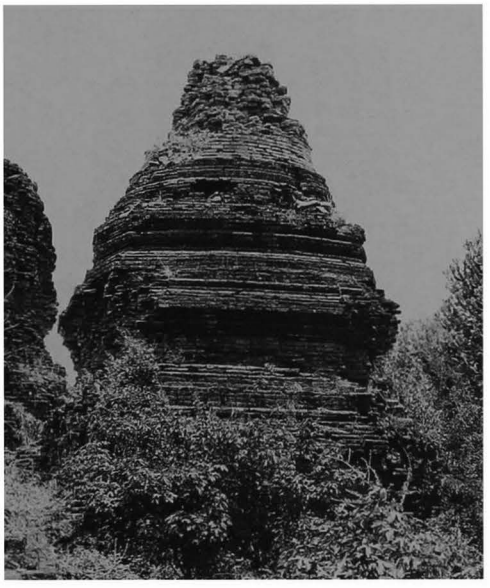
1691 b - South face

5 present condition
- half-ruined.
- base and terraces disintegrated.
- upper parts nearly destroyed.

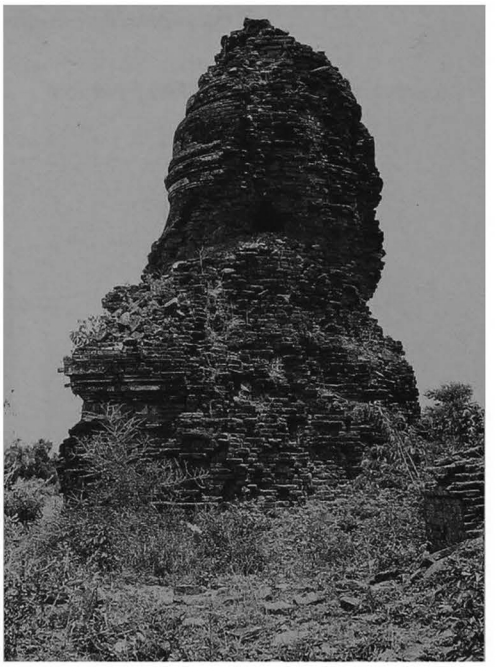
1692 c - From south

5 present condition
- no maintenance.
- base and terraces disintegrated.
- upper parts badly damaged and endangered.

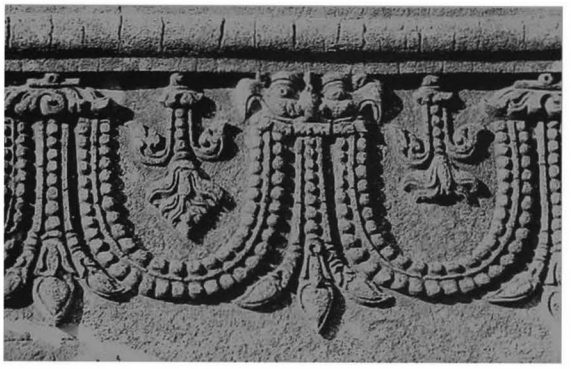
1694 c - South face, detail of frieze

5 present condition
- maintained.
- west porch collapsed.
- west wall repaired (Arch. Dept.) 1981.

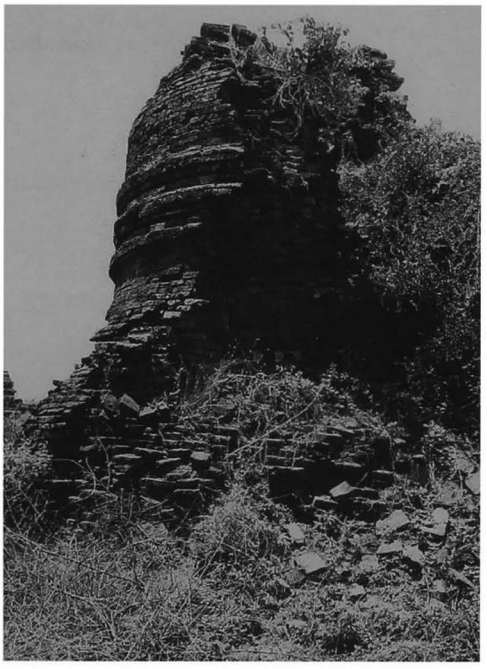
1696 b - From north-east

5 present condition
- no maintenance.
- half-ruined.
- terrace disintegrated.
- upper parts badly damaged.

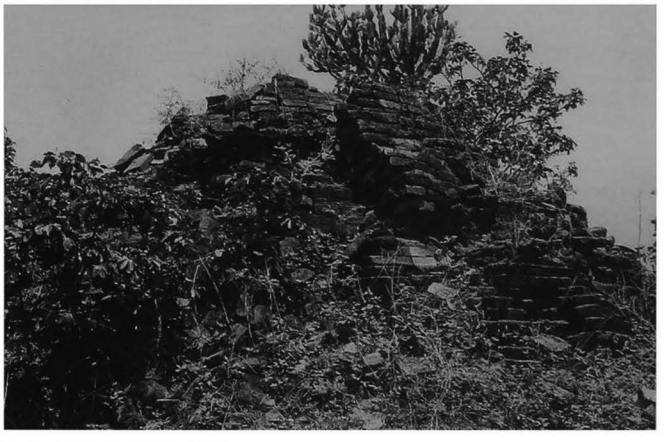
1697 c - From south-west

5 present condition
- ruined.
- terraces disintegrated.
- upper parts destroyed.

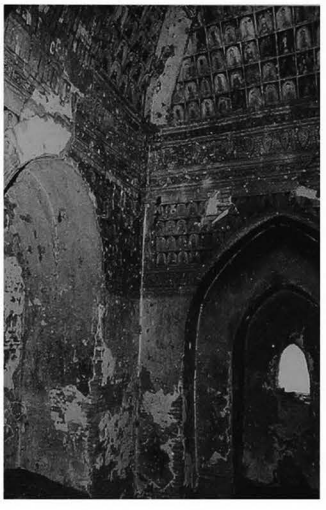
1699 e - Shrine, south-west corner

5 present condition
- no maintenance.
- base disintegrated.
- structure cracked.
- upper parts badly damaged.

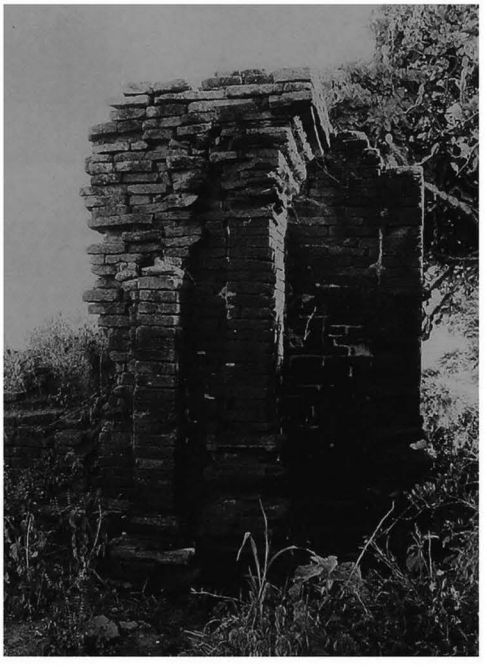
1703 b - North-west corner, from north

5 present condition
- ruined.
- only north-west corner remains.
- ground floor buried under debris.

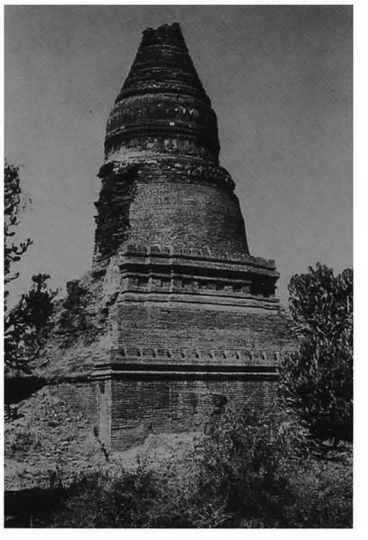
1705 d - From south-east, under repair (1995)

5 present condition
- terraces disintegrated.
- repaired (Arch. Dept.) 1994-95.

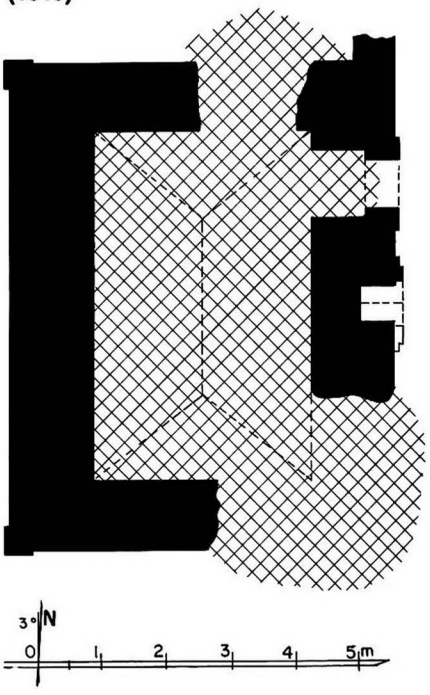
1711 a - Plan

5 present condition
- ruined.
- vaults and roof collapsed.
- ground floor buried under debris.

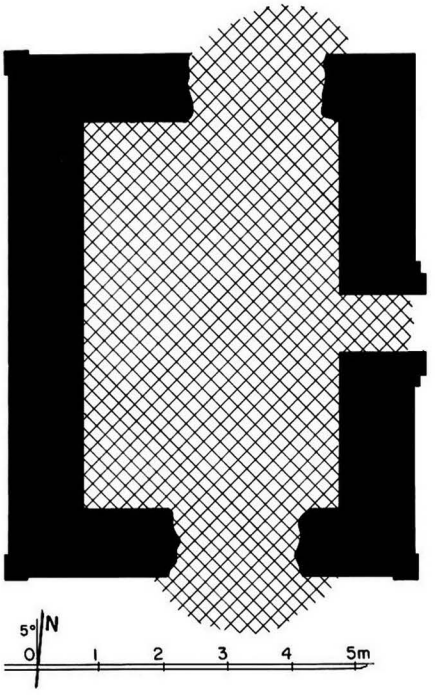
1714 a - Plan

5 present condition
- ruined.
- vault and roof collapsed.
- ground floor buried under debris.

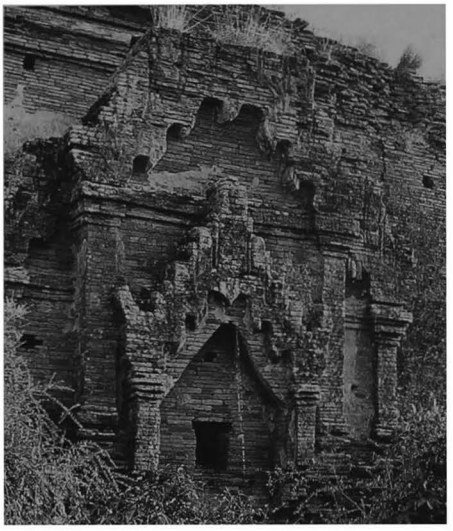
1715 c - North forepart, from north-east (1987)

5 present condition
- east wall and vault partly collapsed.
- upper storey nearly destroyed.
- repaired and strengthened (Arch. Dept.) 1994-95.

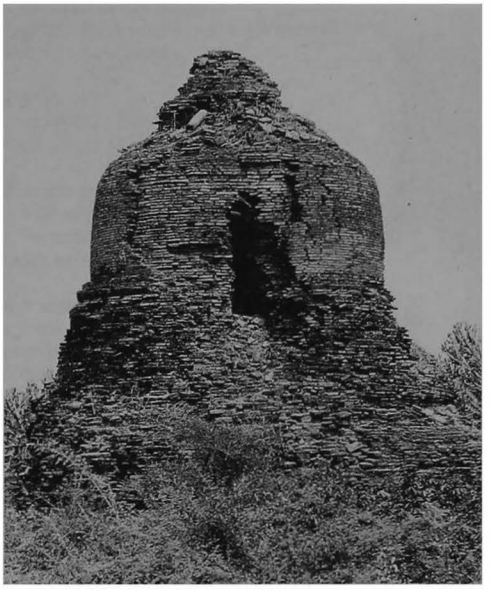
1722 b - From south-east

5 present condition
- no maintenance.
- base and terraces disintegrated.
- upper parts badly damaged.

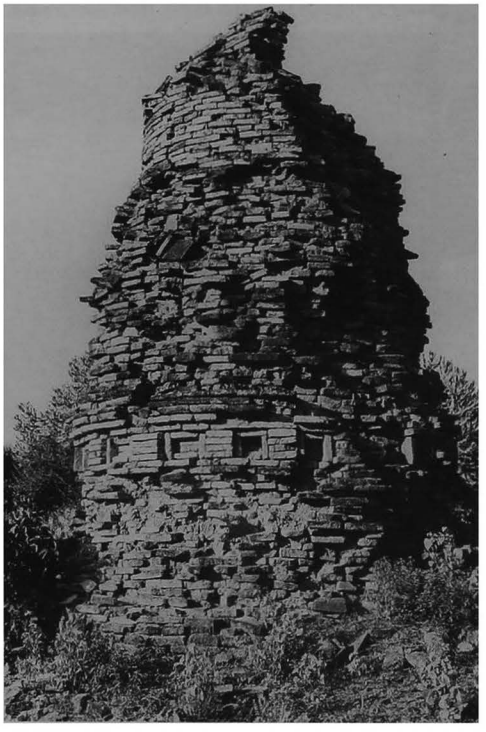
1723 b - From south-west

5 present condition
- no maintenance.
- base and terraces disintegrated.
- upper parts badly damaged.

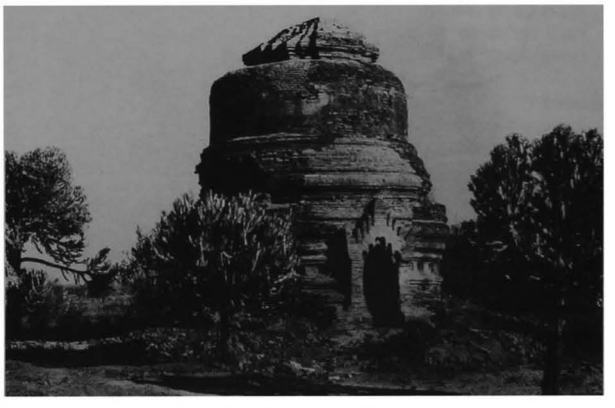
1724 c - From north-west, after repairs (1995)

5 present condition
- repaired (Arch. Dept.) 1994.

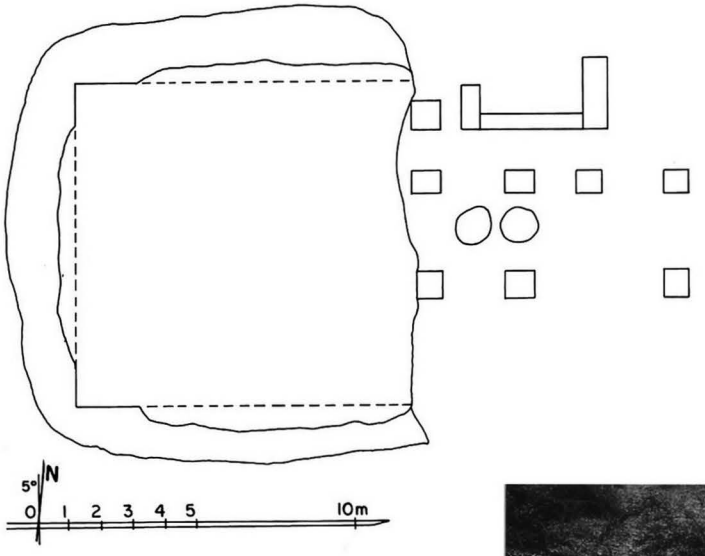
1732 b - East part, from west

5 present condition
- ruined.
- walls and vault collapsed.
- present height 1.80 m.
- ground floor buried under debris.
- west side partially excavated by gold diggers in 1987.

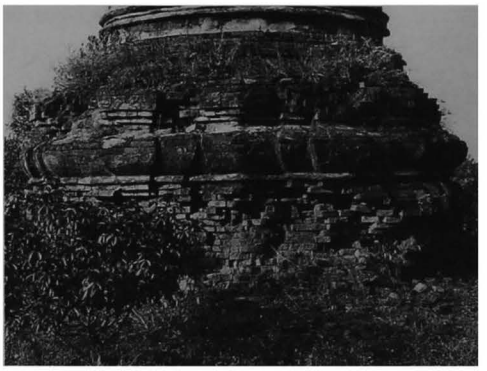
1735 c - Base and terraces, from south-west

5 present condition
- no maintenance.
- base, terrace and upper parts damaged.
- base buried under debris.

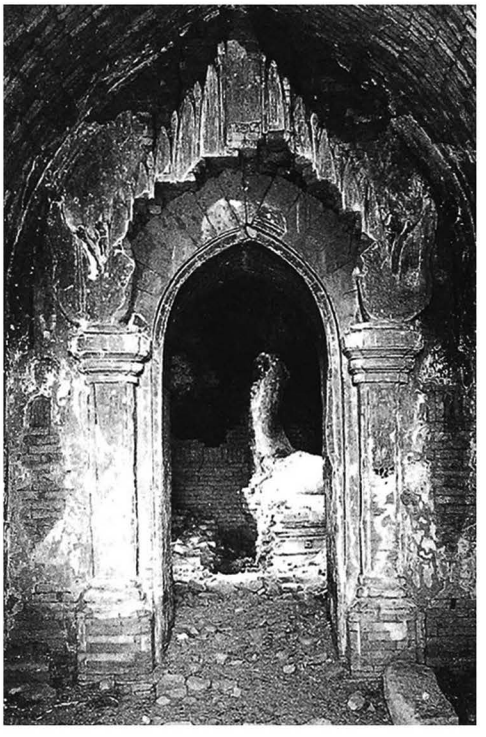
1737 f - Entrance hall, north arch, detail on west side

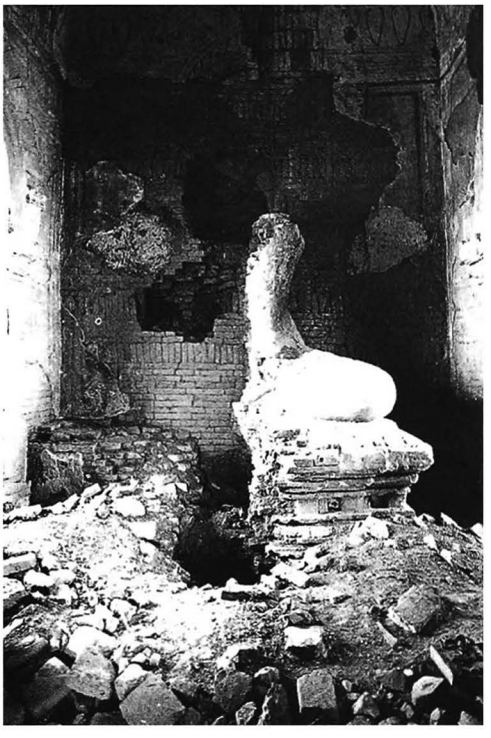
1737 g - Entrance hall and passage, from north

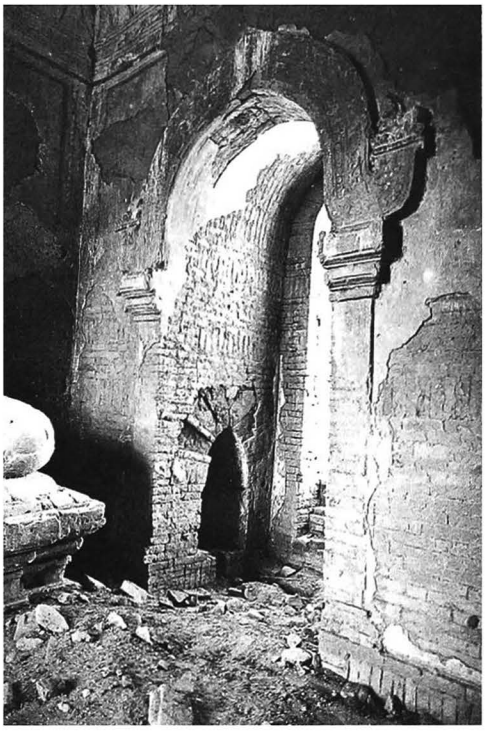
1737 h - Shrine and image, from north

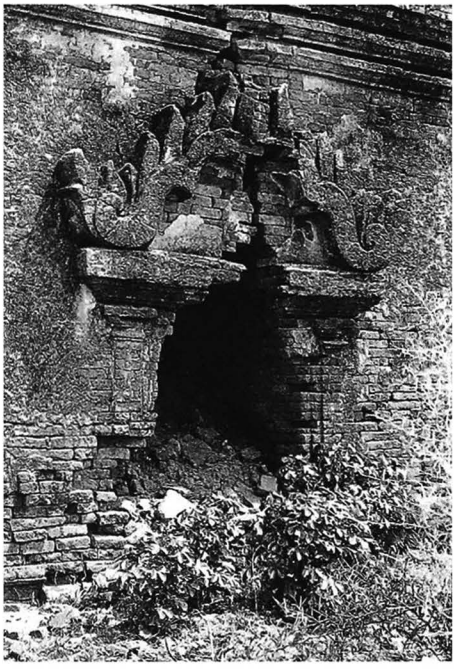
5 present condition
- ruined.
- north wall, vaults and upper parts collapsed.
- ground floor buried under debris.

1738 c - South face

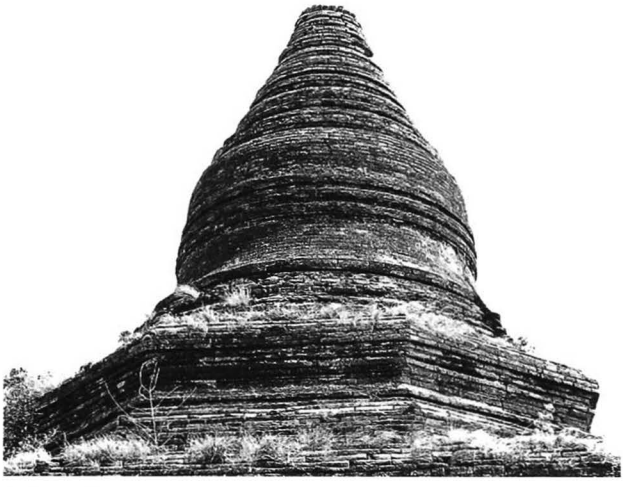
5 present condition
- no maintenance.
- base and terraces badly damaged.

1739 b - East face

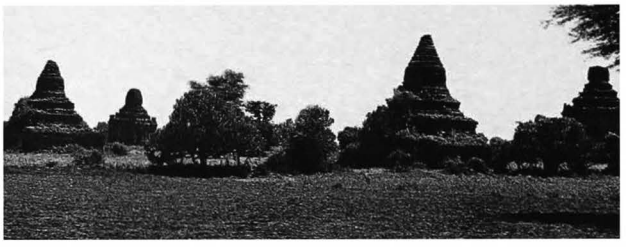
5 present condition
- no maintenance.
- base and terraces disintegrated.
- upper parts badly damaged.

1740 c - South face

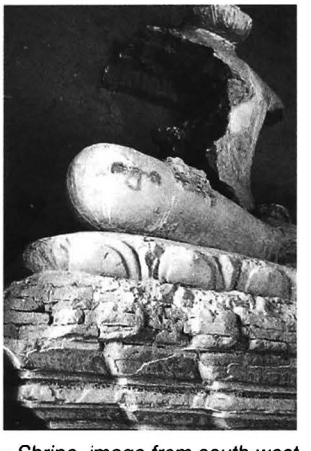
5 present condition
- no maintenance.
- half-ruined.
- base disintegrated.
- vaults over entrance hall collapsed with south wall.
- upper parts badly damaged.
- ground floor partly buried under debris.

1741 d - East face

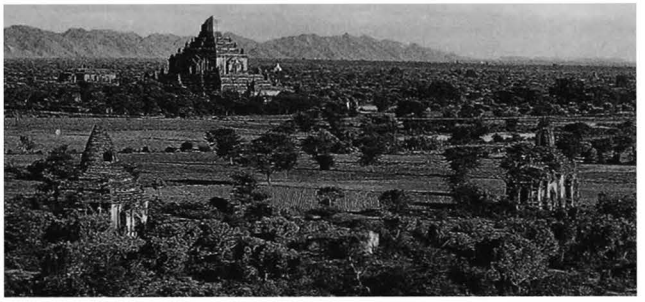
5 present condition
- structure cracked by the 1975 earthquake.
- repaired (Const. Corp) 1989-90.

1743 b - From north-west (1987), together with 1737 and 748 in background

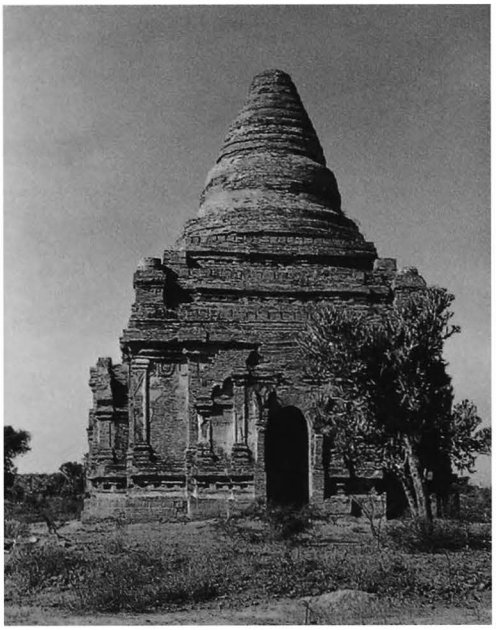
1743 c - From north-east (1987)

1743 d - East face (1995), from east, after repair

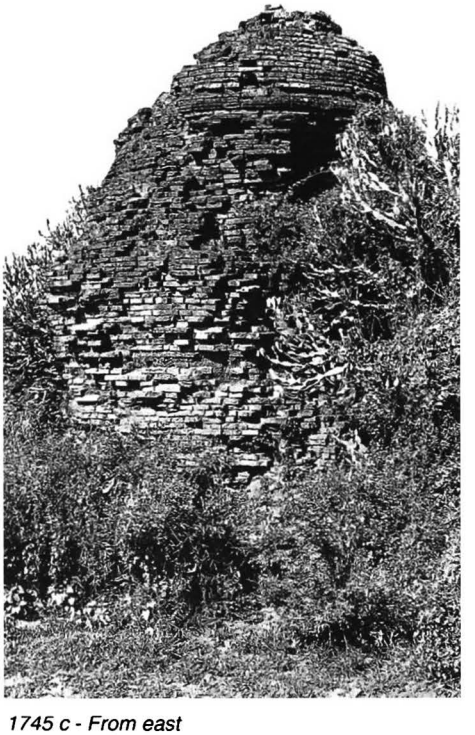
5 present condition
- half-ruined.
- terraces disintegrated.
- upper parts badly damaged.

1745 b - From north-east

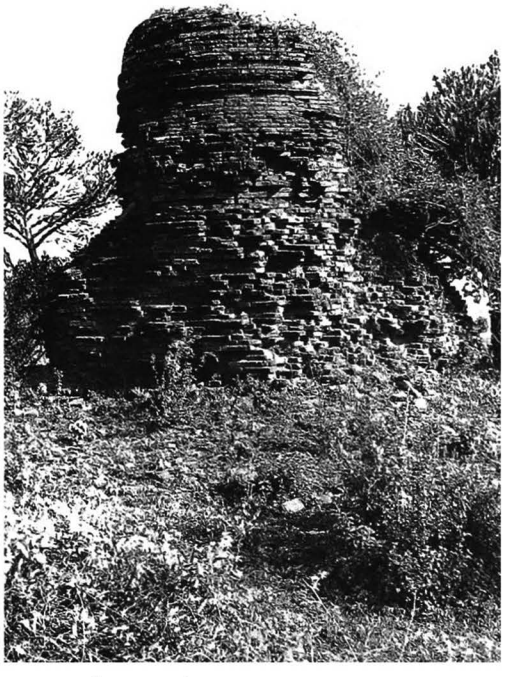
5 present condition
- half-ruined.
- terraces disintegrated.
- upper parts badly damaged.

1746 b - From east

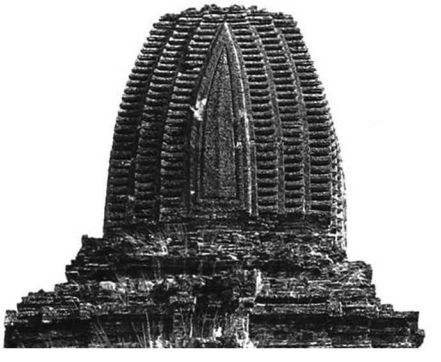
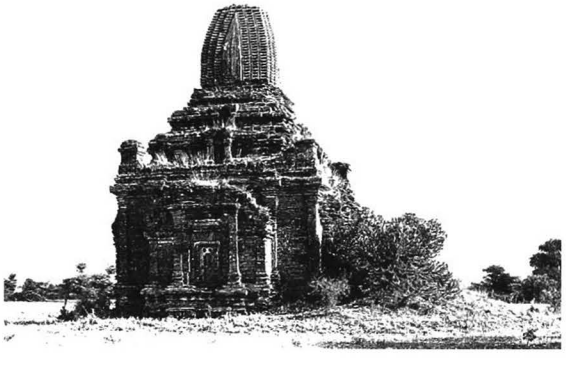
1747 c - Tower, south face

1747 d - South face

1747 e - South face, detail of flat arch over window

5 present condition
- no maintenance.
- vaults and walls of entrance hall collapsed.
- ground floor partly buried under debris.

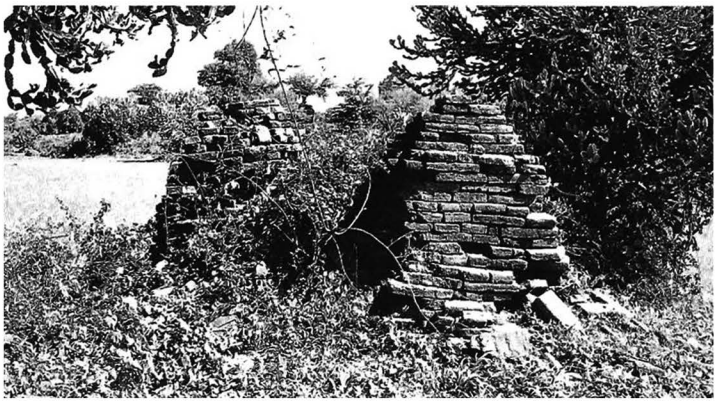
5 present condition
- ruined.
- terraces disintegrated.
- upper parts destroyed.

1748 b - From east

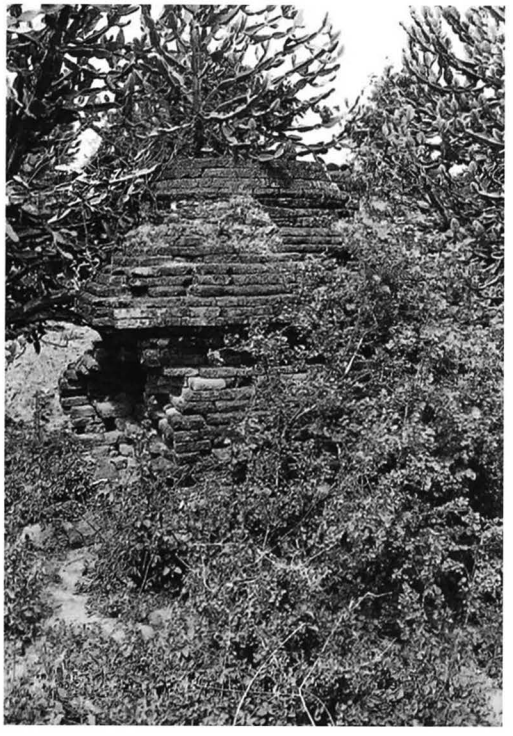
5 present condition
- ruined.
- terraces badly damaged.
- upper parts nearly destroyed.

1753 b - From south-east

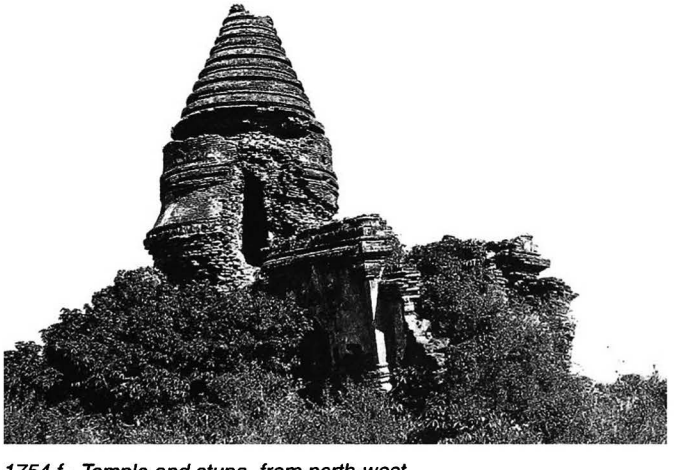
stupa:
- base and terraces disintegrated.
- upper parts badly damaged.

1754 f - Temple and stupa, from north-west

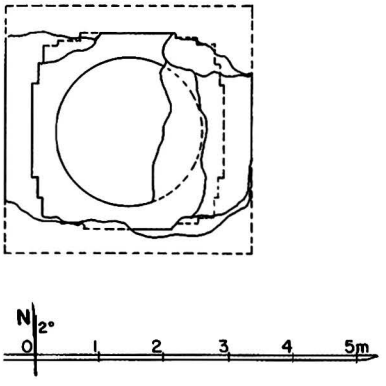
1759 a - Plan

5 present condition
- ruined.
- base and terraces disintegrated.
- upper parts destroyed.

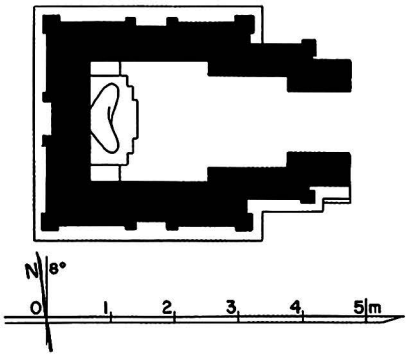
1761 a - Plan

5 present condition
- ruined.
- only base of walls remains.
- present height 1.70 m.
- excavated (Arch. Dept.) 1995-96.

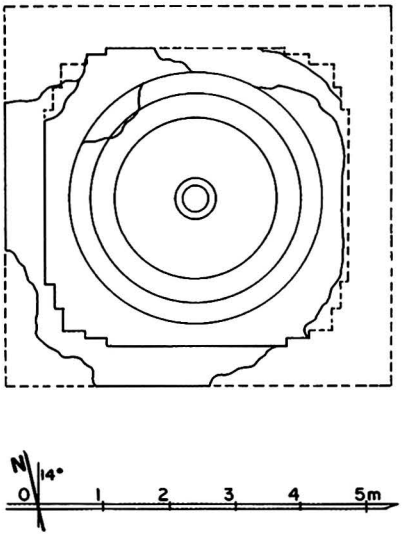
1762 a - Plan

5 present condition
- no maintenance.
- base and terraces disintegrated.
- top of spire displaced by the 1975 earthquake.

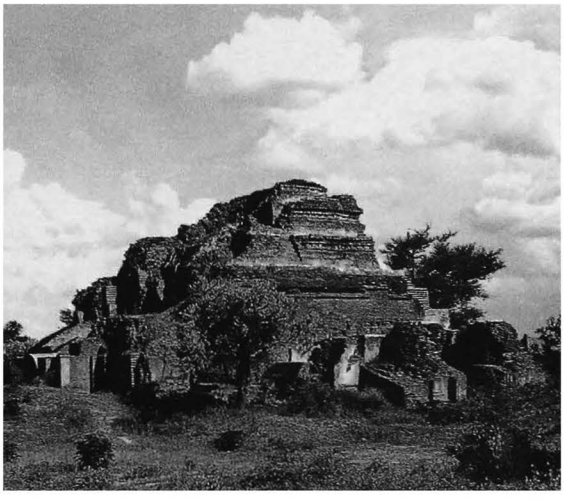
1774 d - From north-west (1995), after repairs

5 present condition
- base disintegrating.
- cleared of debris, 1986-89.
- repaired (Const. Corp.) 1991-92.

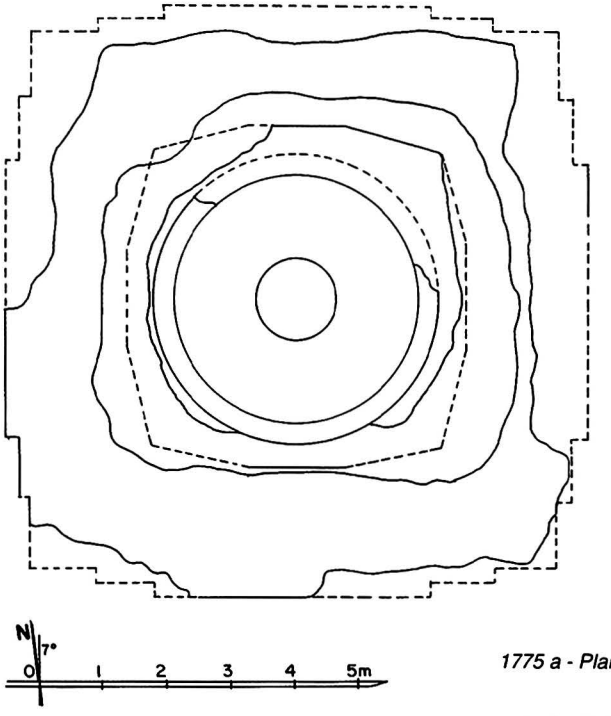
1775 a - Plan

5 present condition
- half-ruined.
- terraces disintegrated.
- upper parts badly damaged.

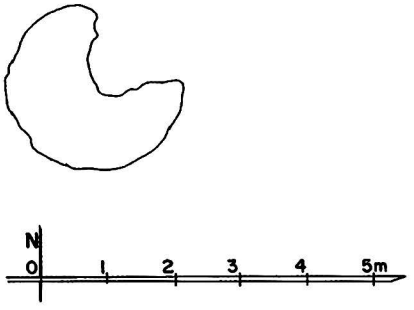
1776 a - Plan

5 present condition
- ruined.
- base and terraces disintegrated.
- upper parts destroyed.
- present height: 1.90 m.
- cleared of debris and consolidated, 1994.

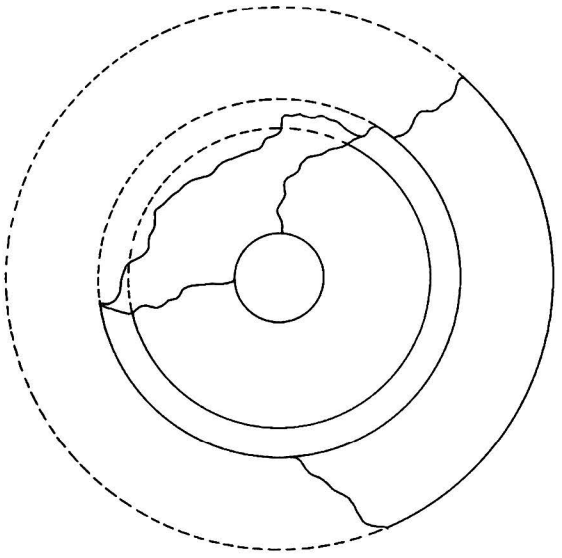
1780 a - Plan

5 present condition
- base and terraces disintegrated.
- upper parts badly damaged.
- repaired (Arch. Dept.) 1993.

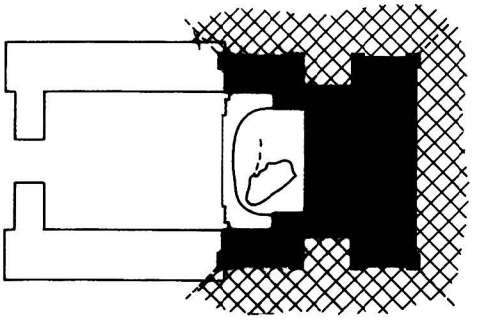
1781 a - Plan

5 present condition
- only core and tower remain.
- outer wall and vault over corridor collapsed.
- base and ground floor buried under debris.
- leaning westward.
- stabilized with brick buttresses (Arch. Dept.), 1982.

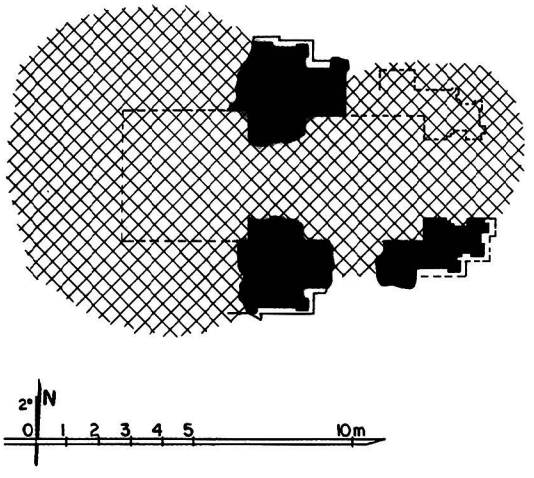
1783 a - Plan

5 present condition
- ruined.
- only base of east part remains.
- ground floor buried under debris.
